BENTON IRRIGATION DISTRICT
 IRRIGATION SYSTEM IMPROVEMENTS
 PHASE I
 WHAN ROAD PIPING
 PLAN AND PROFILE - STA. 8+00 TO 22+00

BASE BID
 SHEET
5

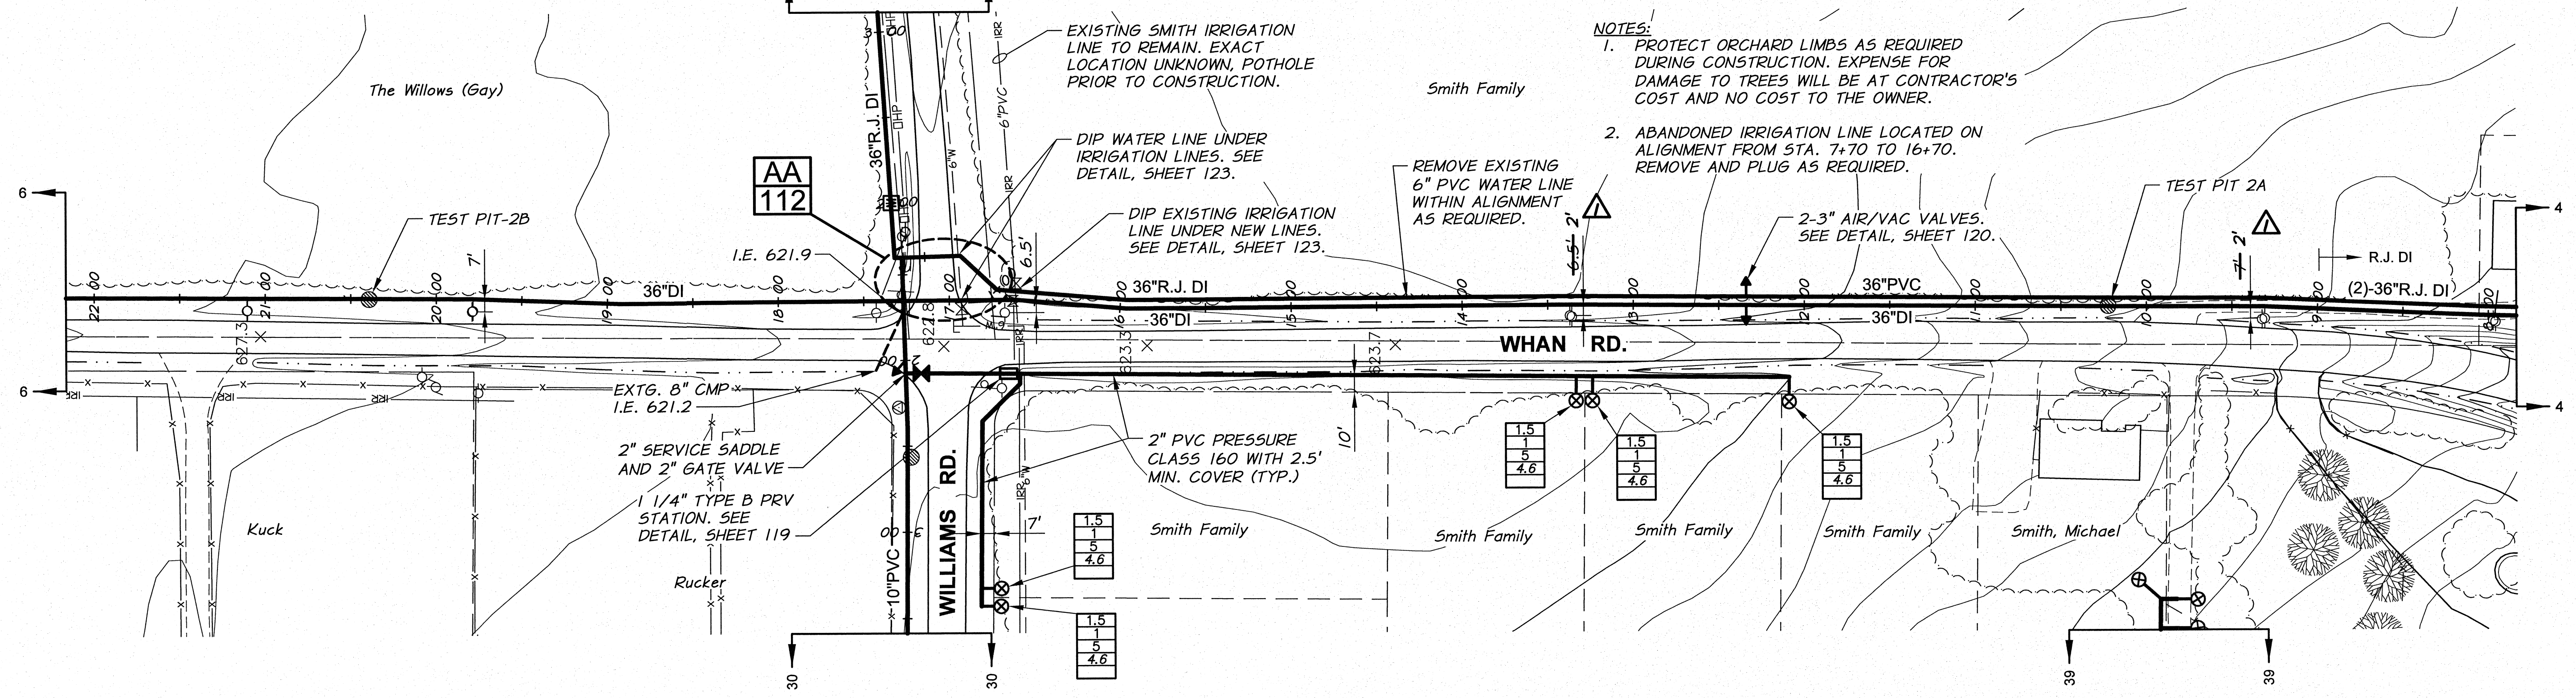
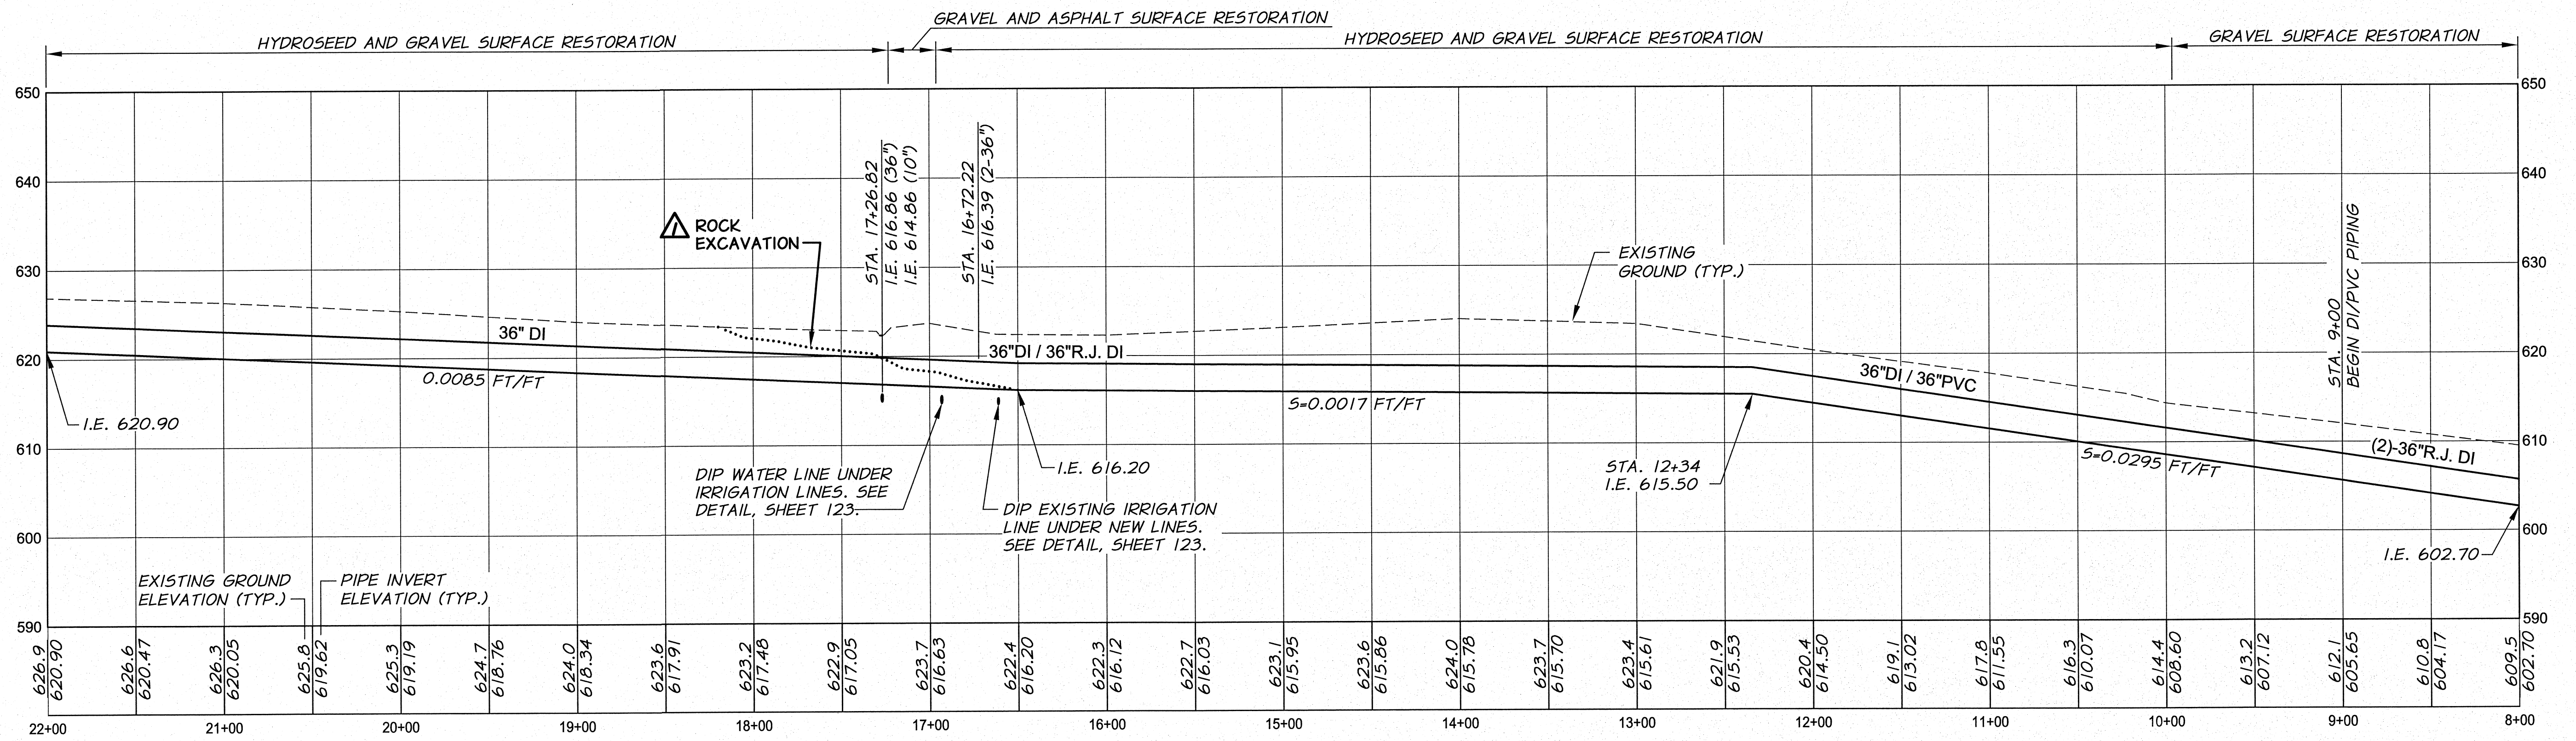
- NOTES:**
1. PROTECT ORCHARD LIMBS AS REQUIRED DURING CONSTRUCTION. EXPENSE FOR DAMAGE TO TREES WILL BE AT CONTRACTOR'S COST AND NO COST TO THE OWNER.
 2. ABANDONED IRRIGATION LINE LOCATED ON ALIGNMENT FROM STA. 7+70 TO 16+70. REMOVE AND PLUG AS REQUIRED.
