DESIGNED BY	R. HARRIS	XREFS: TB-BID.dwg	JOB NUMBER	1199-336	DATE	2010
DRAWN BY	E. ARNTZ		ACAD FILE	North_East_A.dwg		
REVIEWED BY	J. HOLLOPETER		COPYRIGHT 2010 BY ANDERSON-PERRY & ASSOC., INC.

**BENTON IRRIGATION DISTRICT**  
 IRRIGATION SYSTEM IMPROVEMENTS  
 PHASE 2A  
 NORTH EAST - HORNE ROAD SOUTH PIPING  
 STA. 13+00 TO STA. 18+33

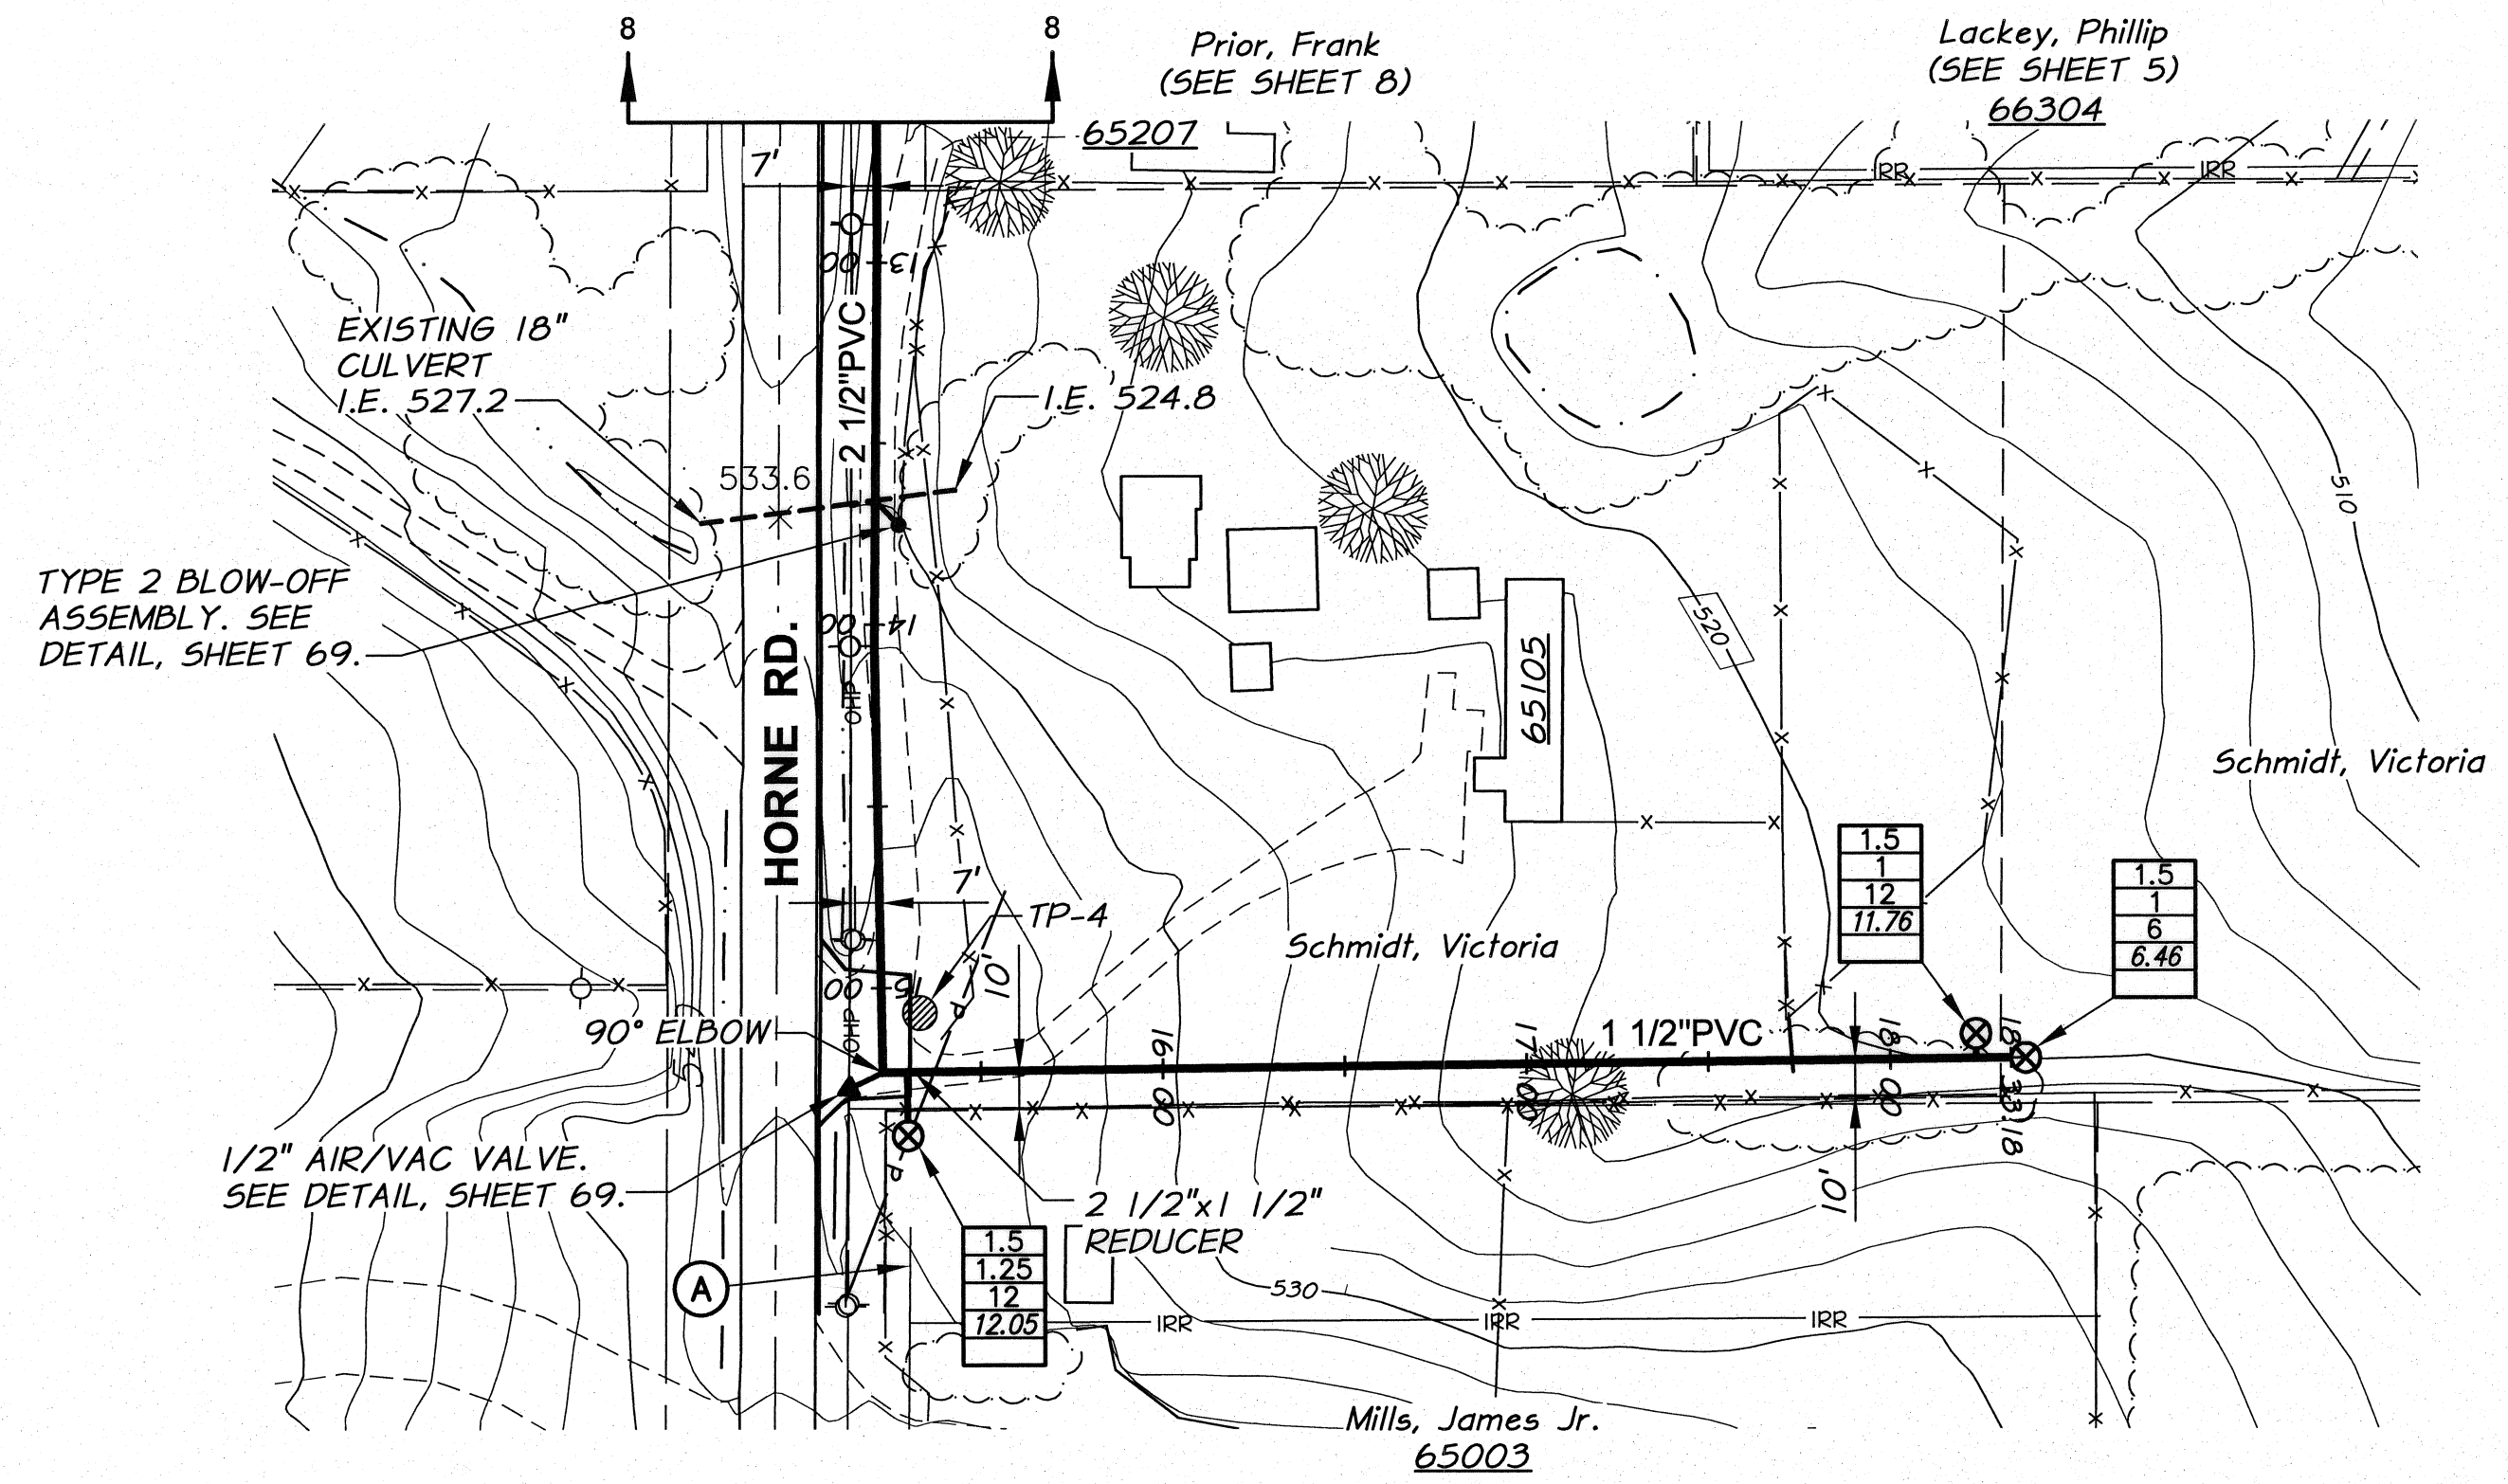
- (A) EXISTING IRRIGATION LINE ALONG OR CROSSING ALIGNMENT. EXACT LOCATION UNKNOWN. REMOVE AND PLUG AS REQUIRED FOR NEW LINE INSTALLATION.
