**BENTON IRRIGATION DISTRICT**  
IRRIGATION SYSTEM IMPROVEMENTS  
PHASE 2A  
NORTH EAST - HORNE TO HIGHLAND EXT. PIPING  
STA. 1+00 TO 4+35 (WEST) AND STA. 1+00 TO 4+90 (EAST)

SHEET  
**22**

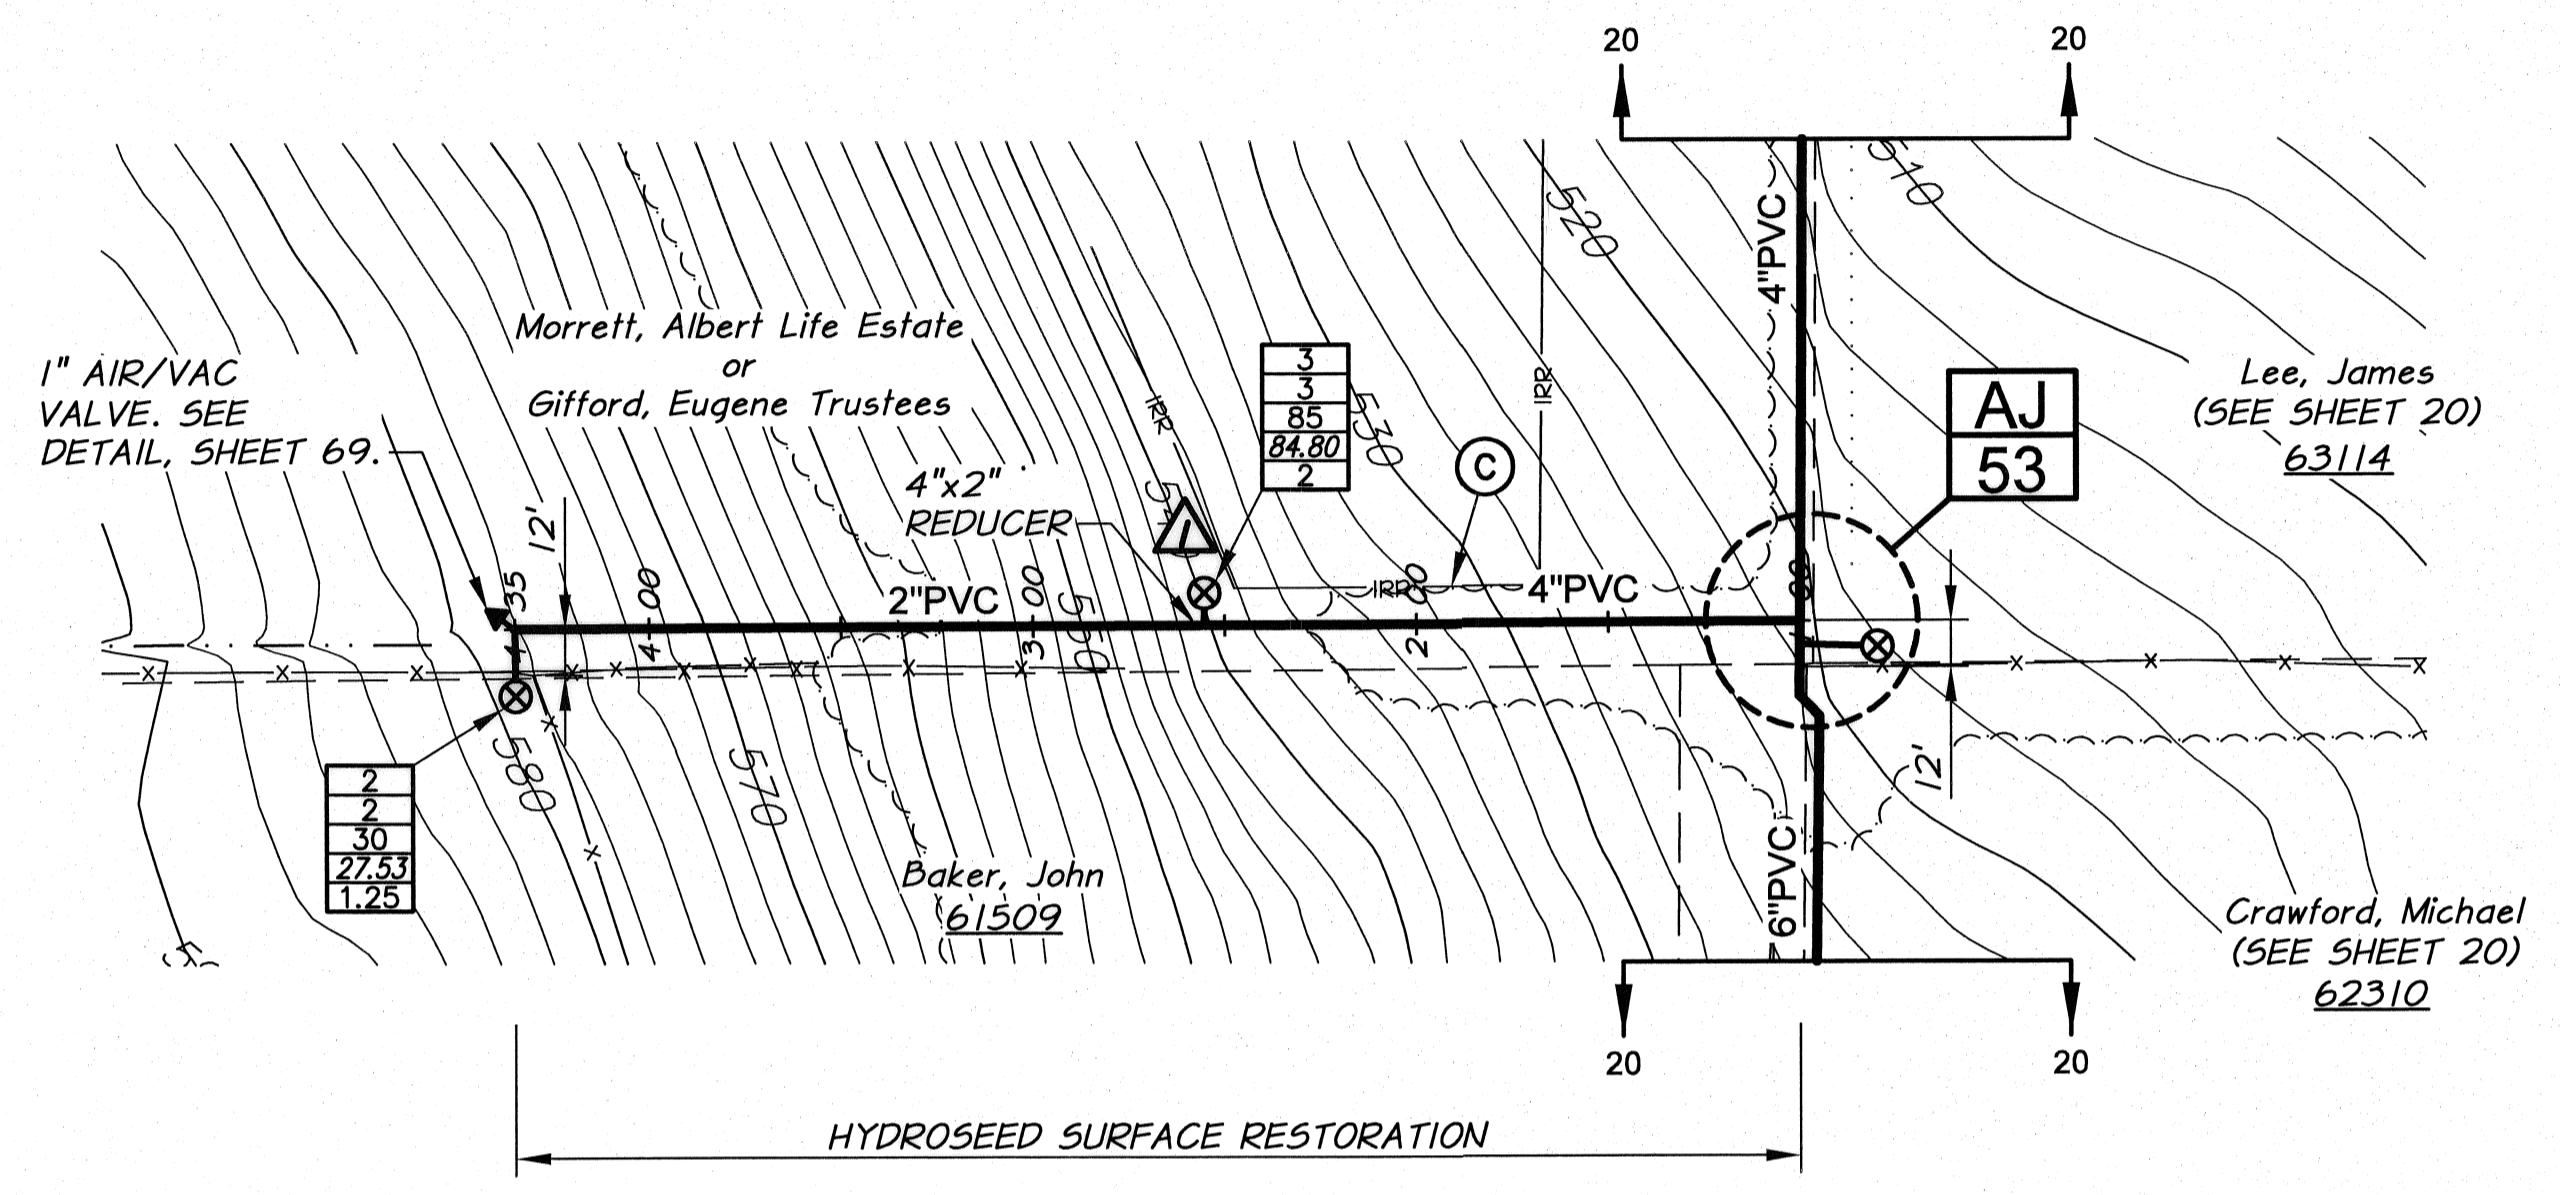
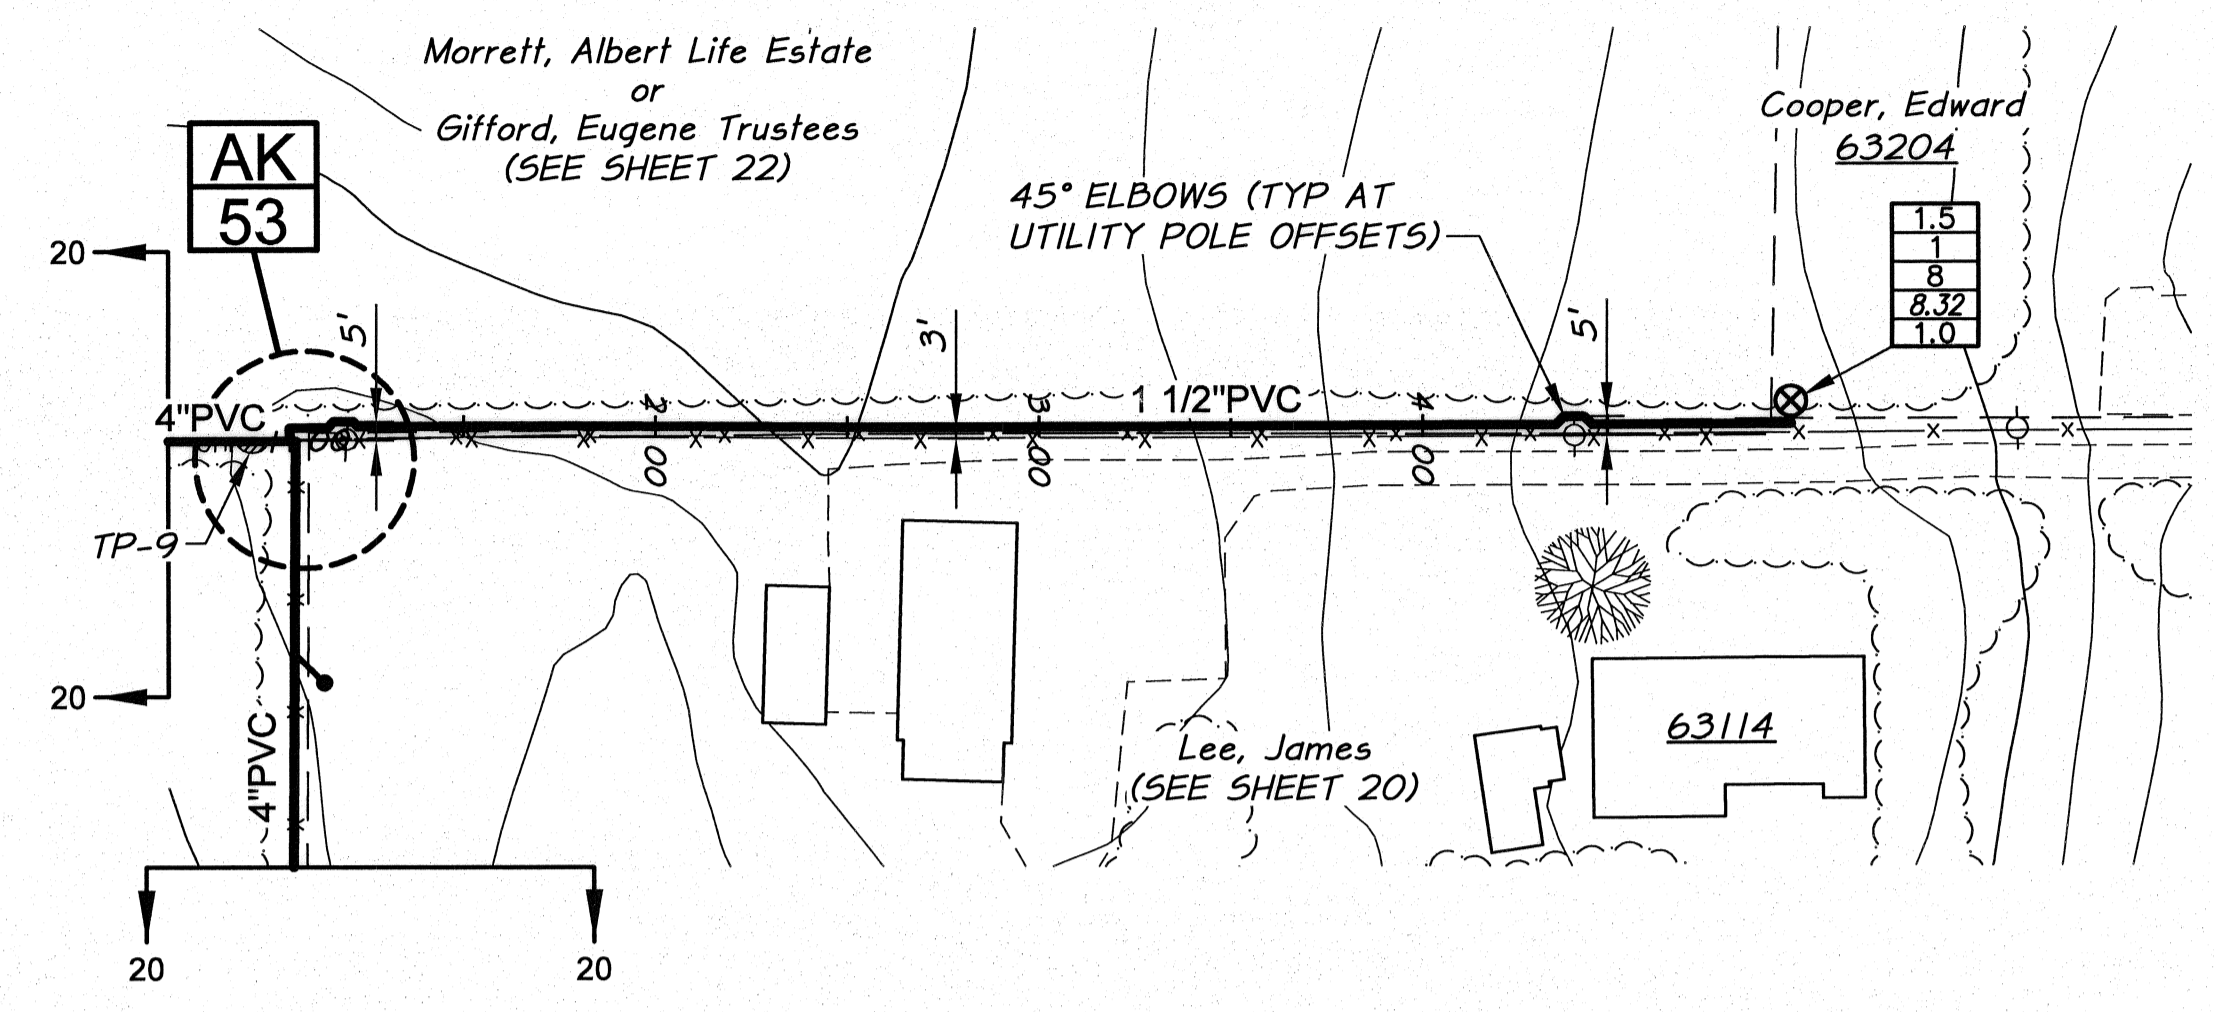
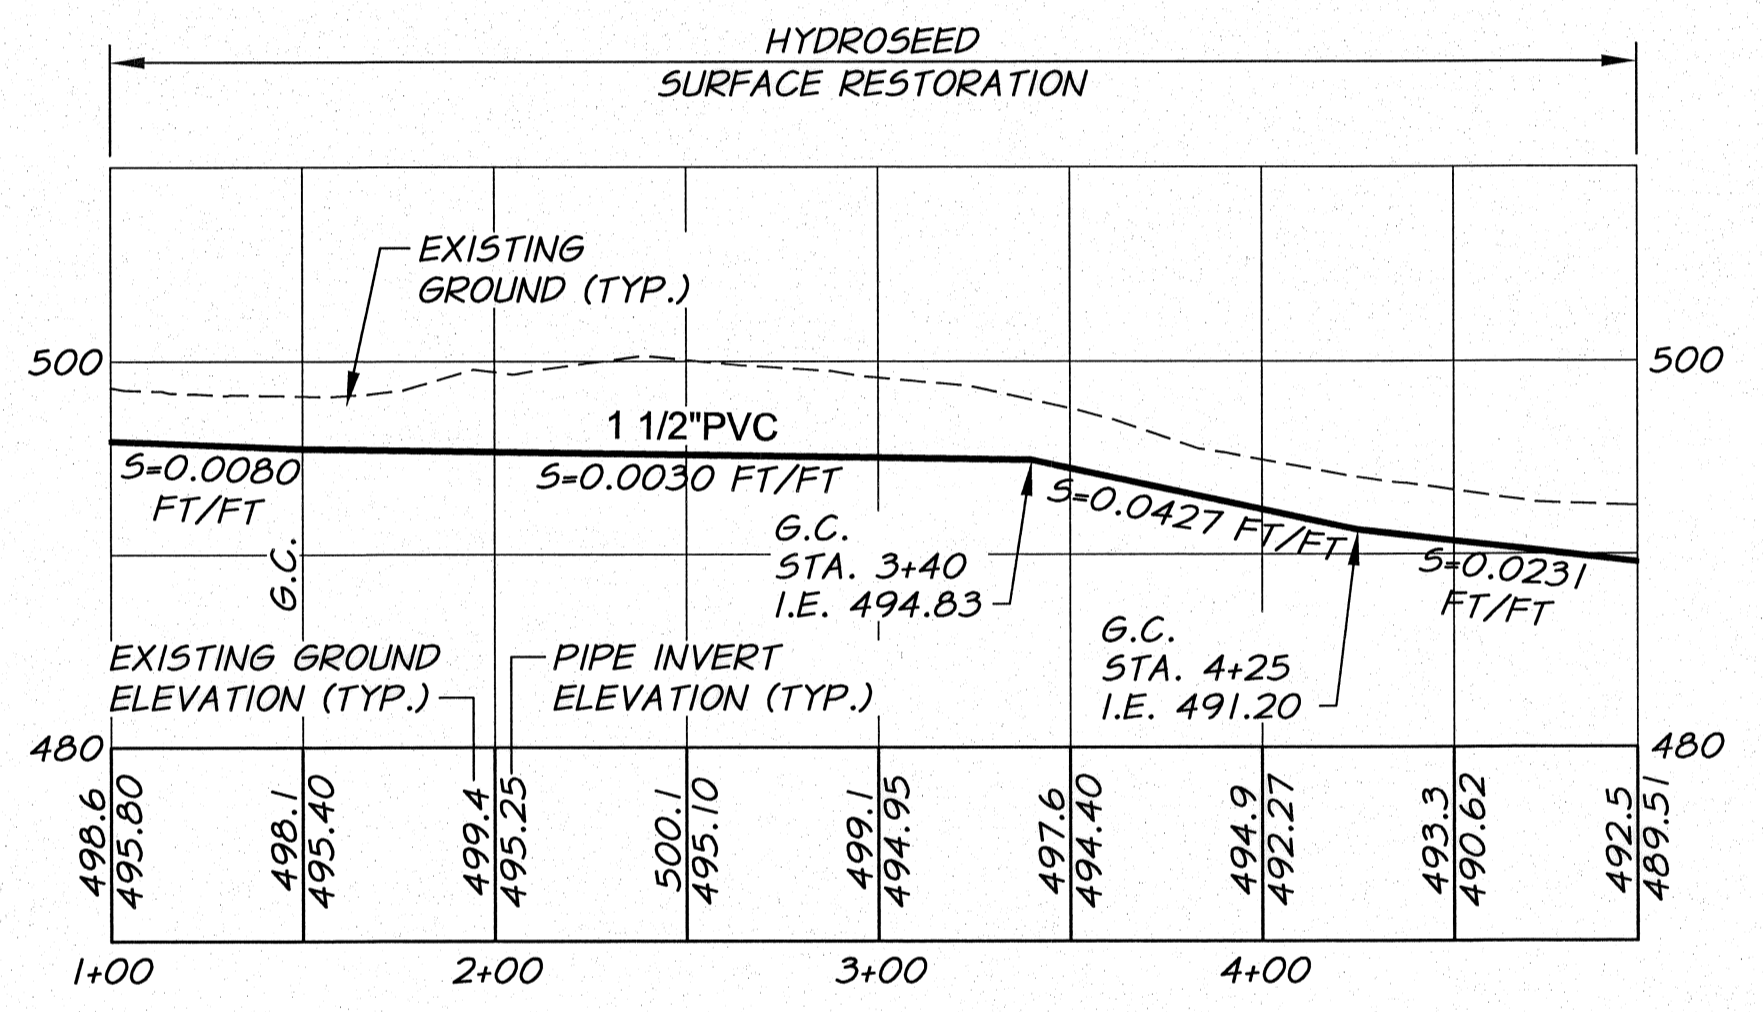
1" AIR/VAC VALVE. SEE DETAIL, SHEET 6.9.

NOTE:  
MAINTAIN 2.5' MIN. COVER AND GRADE TO DRAIN BACK TO MAIN LINE

- (C) EXISTING IRRIGATION LINE ALONG ALIGNMENT TO BE ABANDONED. REMOVE AND PLUG AS REQUIRED FOR NEW LINE INSTALLATION.
