<b>RECORD DRAWING</b>		BY: E.H.	DATE: 4/12
DESIGNED BY: R. HARRIS	XREFS: TB-BID.dwg	JOB NUMBER: 1199-336	DATE: 2010
DRAWN BY: E. ARNTZ		ACAD FILE: East_A.dwg	
REVIEWED BY: J. HOLLOPETER		COPYRIGHT 2010 BY ANDERSON-PERRY & ASSOC., INC.

**BENTON IRRIGATION DISTRICT**  
 IRRIGATION SYSTEM IMPROVEMENTS  
 PHASE 2A  
 EAST - HORNE TO MASON PIPING  
 STA. 1+00 TO 5+61 AND STA. 1+00 TO 6+75

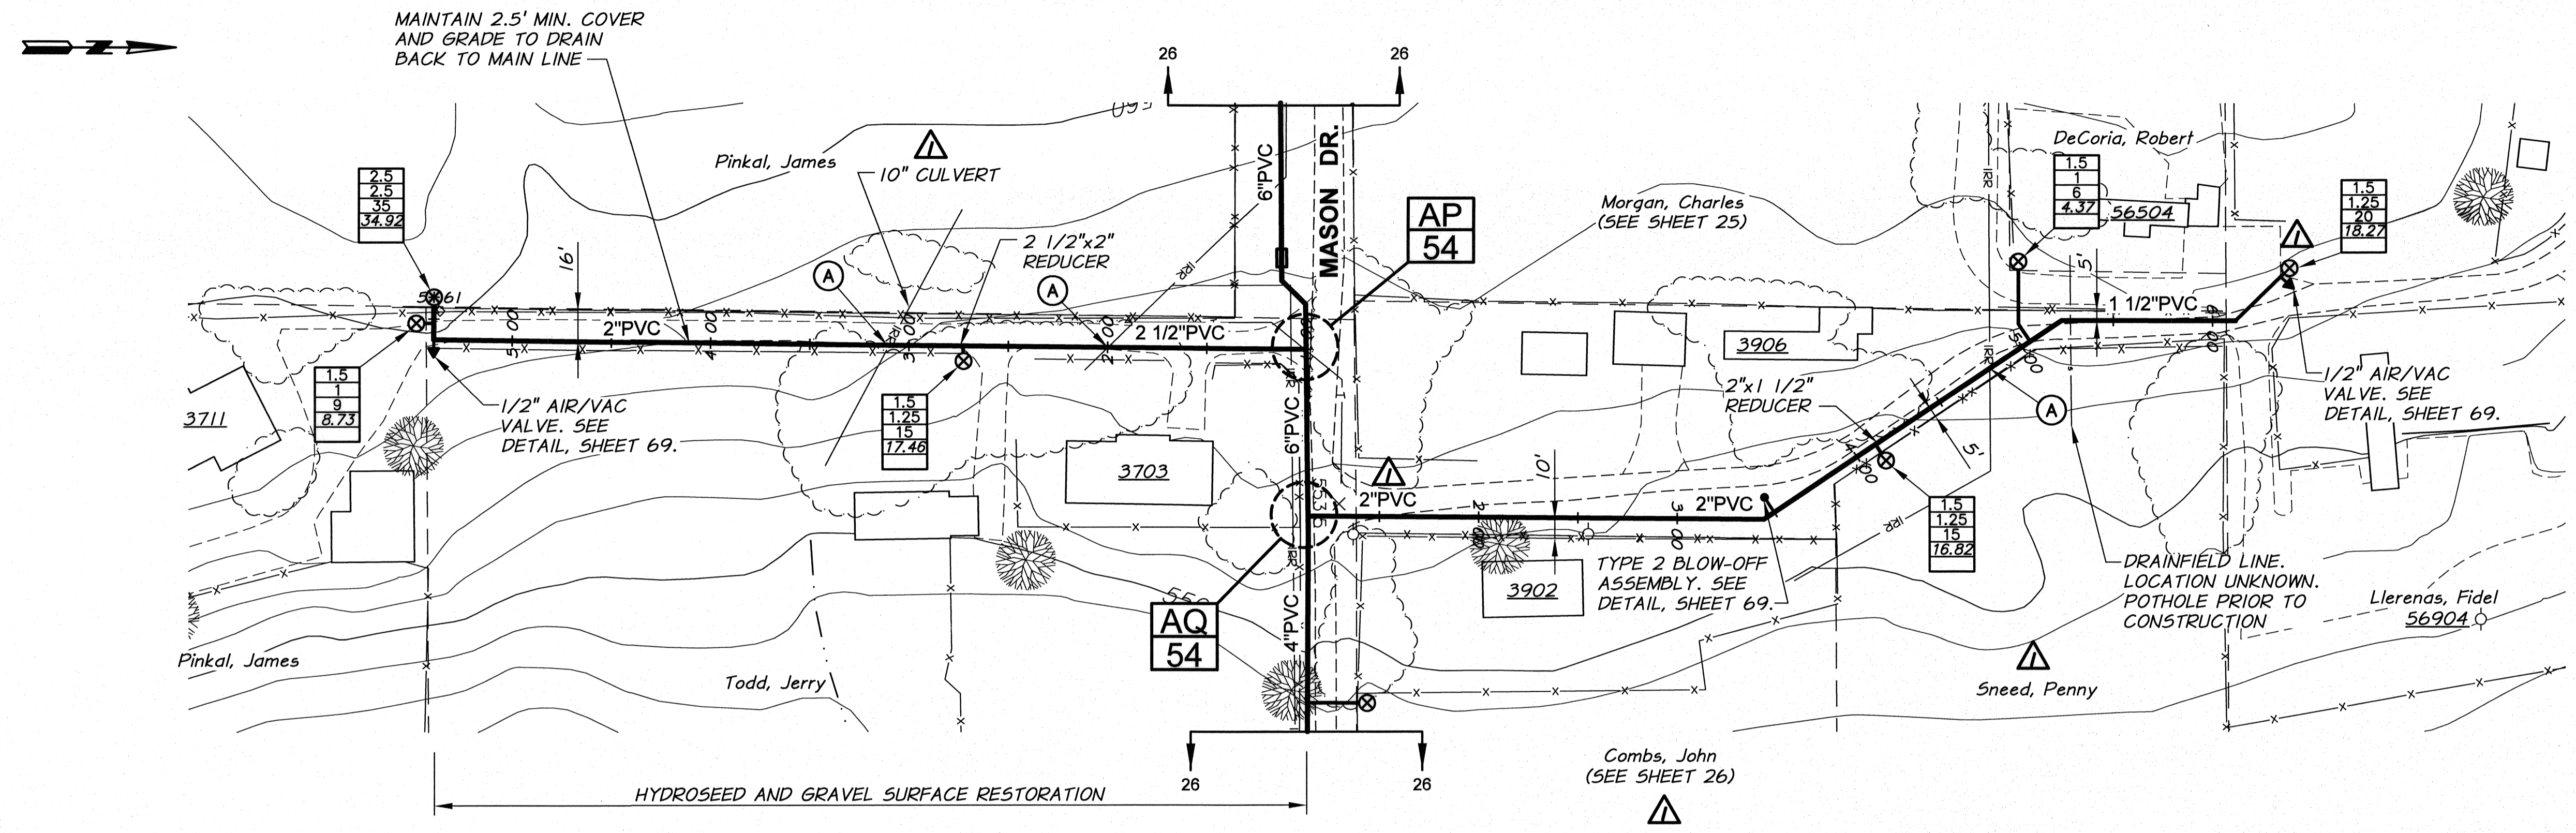
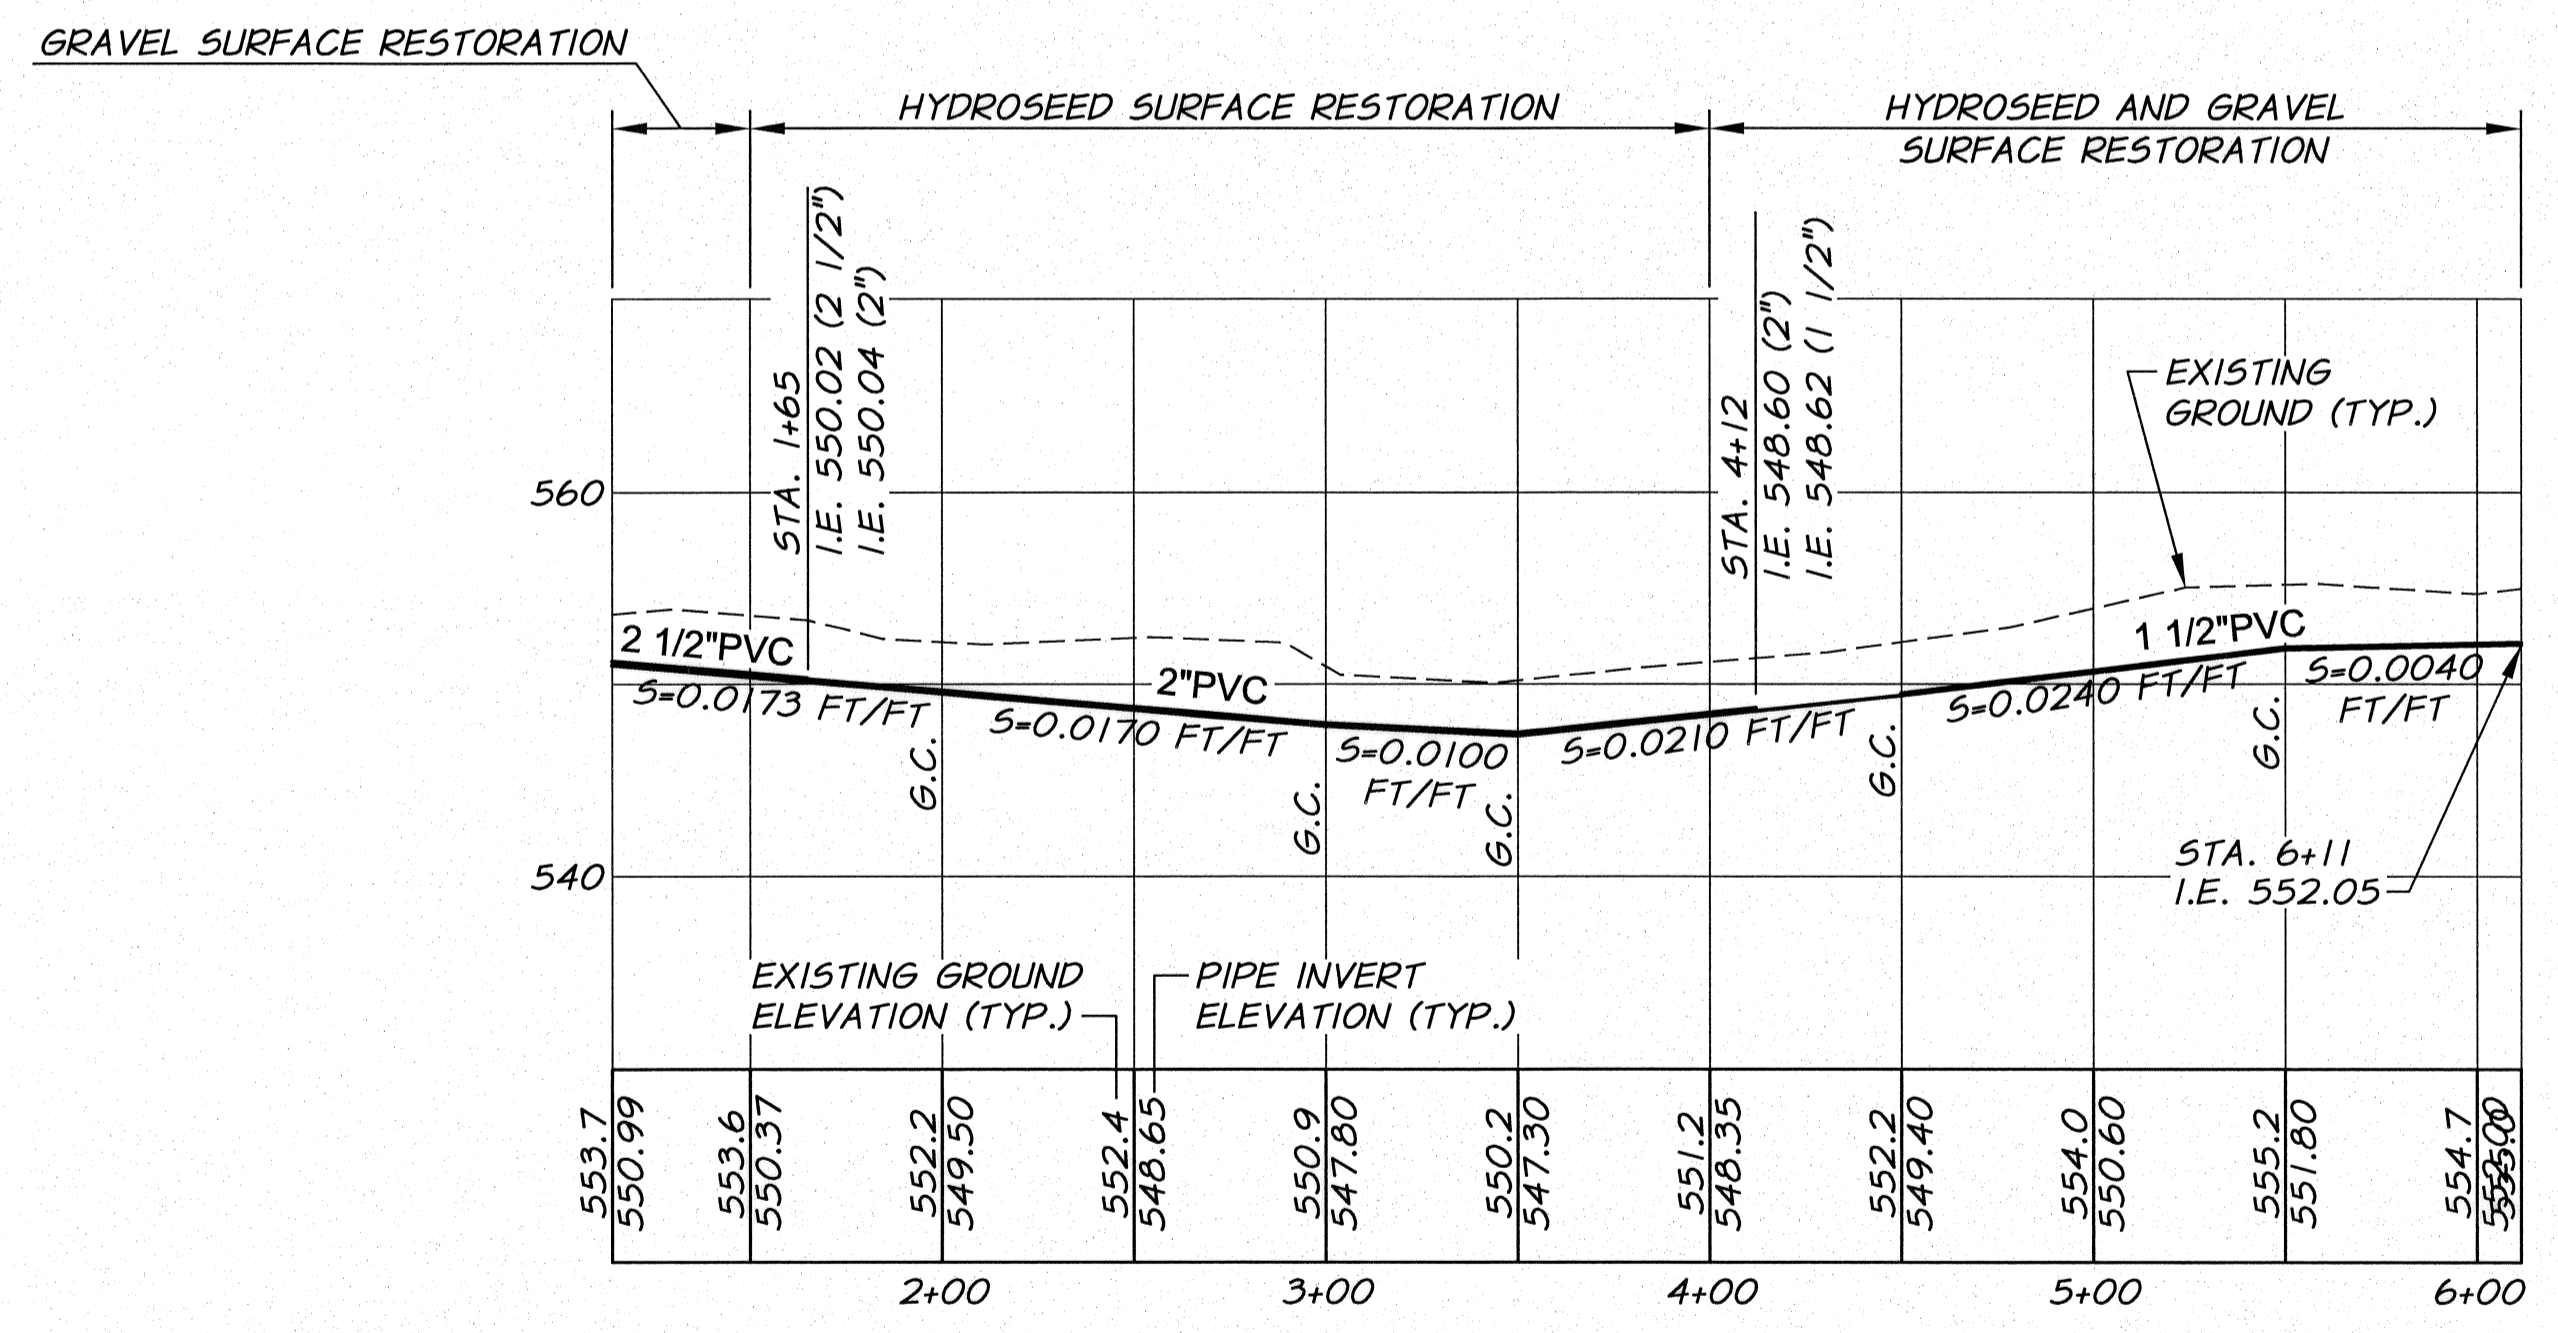
- (A) EXISTING IRRIGATION LINE ALONG OR CROSSING ALIGNMENT. EXACT LOCATION UNKNOWN. REMOVE AND PLUG AS REQUIRED FOR NEW LINE INSTALLATION.
