BENTON IRRIGATION DISTRICT
 IRRIGATION SYSTEM IMPROVEMENTS
 PHASE 2A
 EAST - HORNE TO MASON PIPING
 STA. 1+00 TO STA. 14+00

SHEET
29

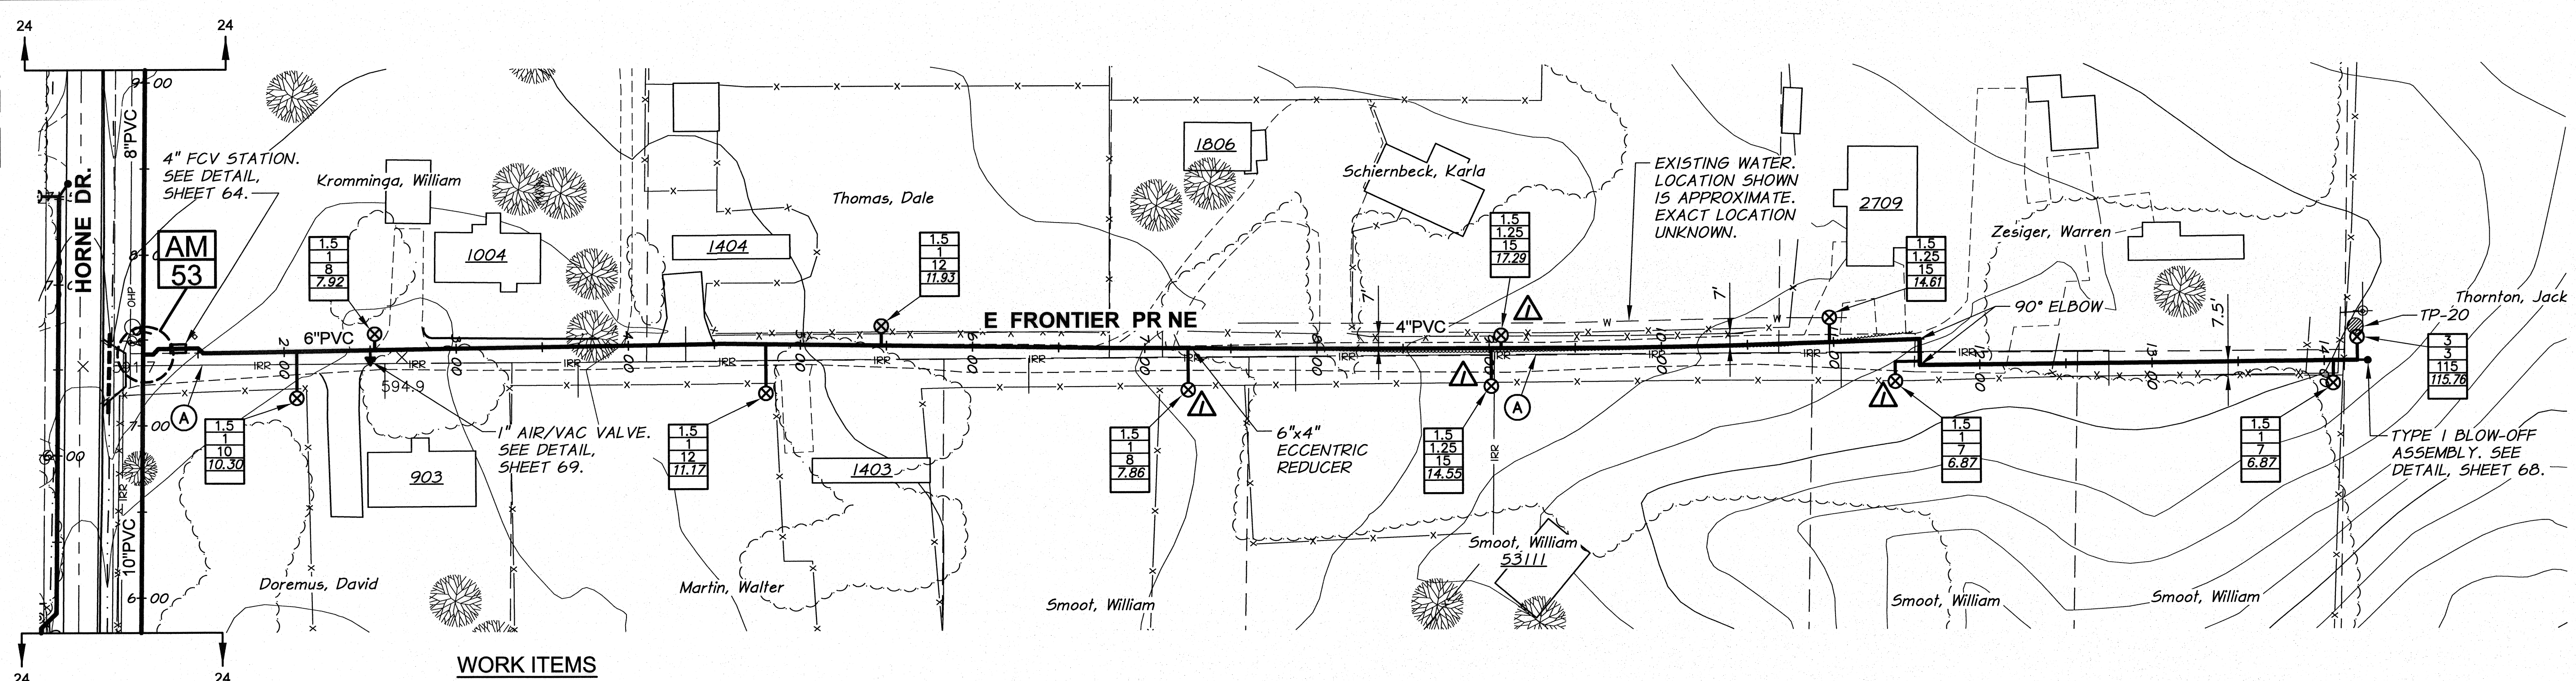
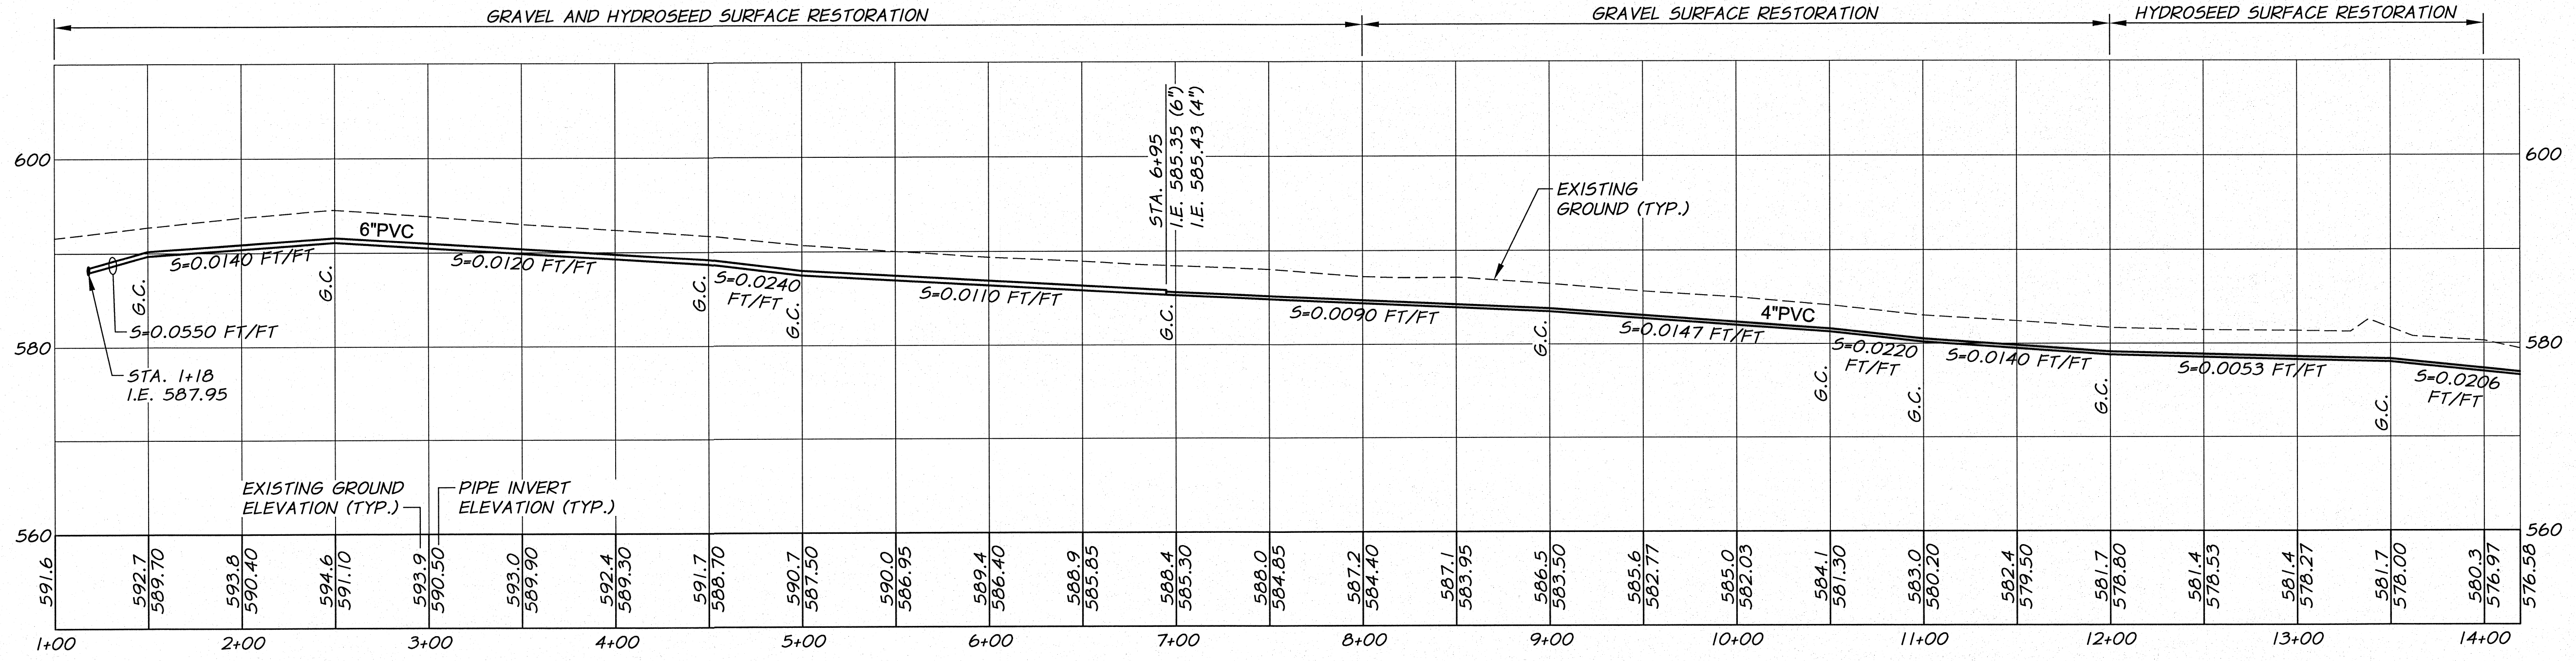
- (A) EXISTING IRRIGATION LINE ALONG OR CROSSING ALIGNMENT. EXACT LOCATION UNKNOWN. REMOVE AND PLUG AS REQUIRED FOR NEW LINE INSTALLATION.

NOTE:
 PROTECT ORCHARD LIMBS AS REQUIRED DURING CONSTRUCTION. EXPENSE FOR DAMAGE TO TREES WILL BE AT CONTRACTOR'S COST, AND NO COST TO THE OWNER.
