BENTON IRRIGATION DISTRICT
IRRIGATION SYSTEM IMPROVEMENTS
PHASE 2A
NORTH - MORGAN TO SUNRISE PIPING
PUMPSTATION TO STA. 15+00

SHEET
34

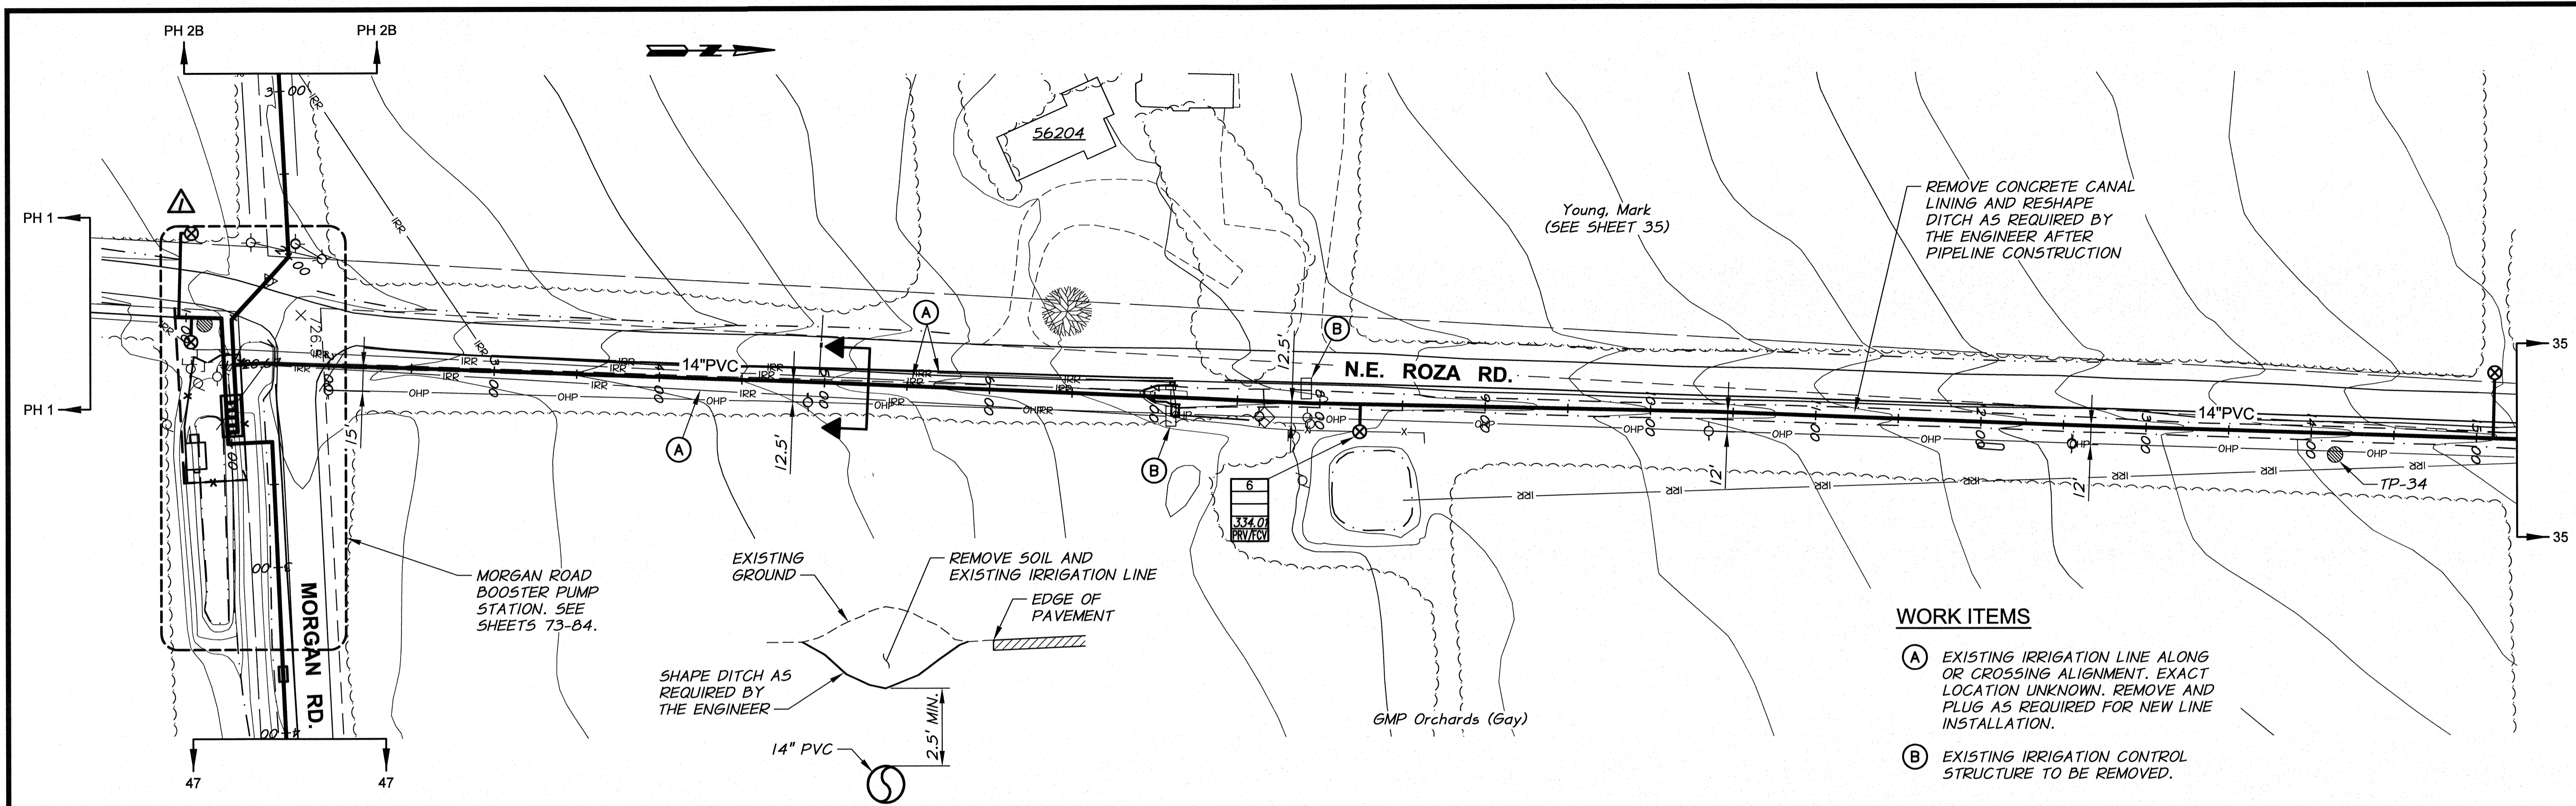
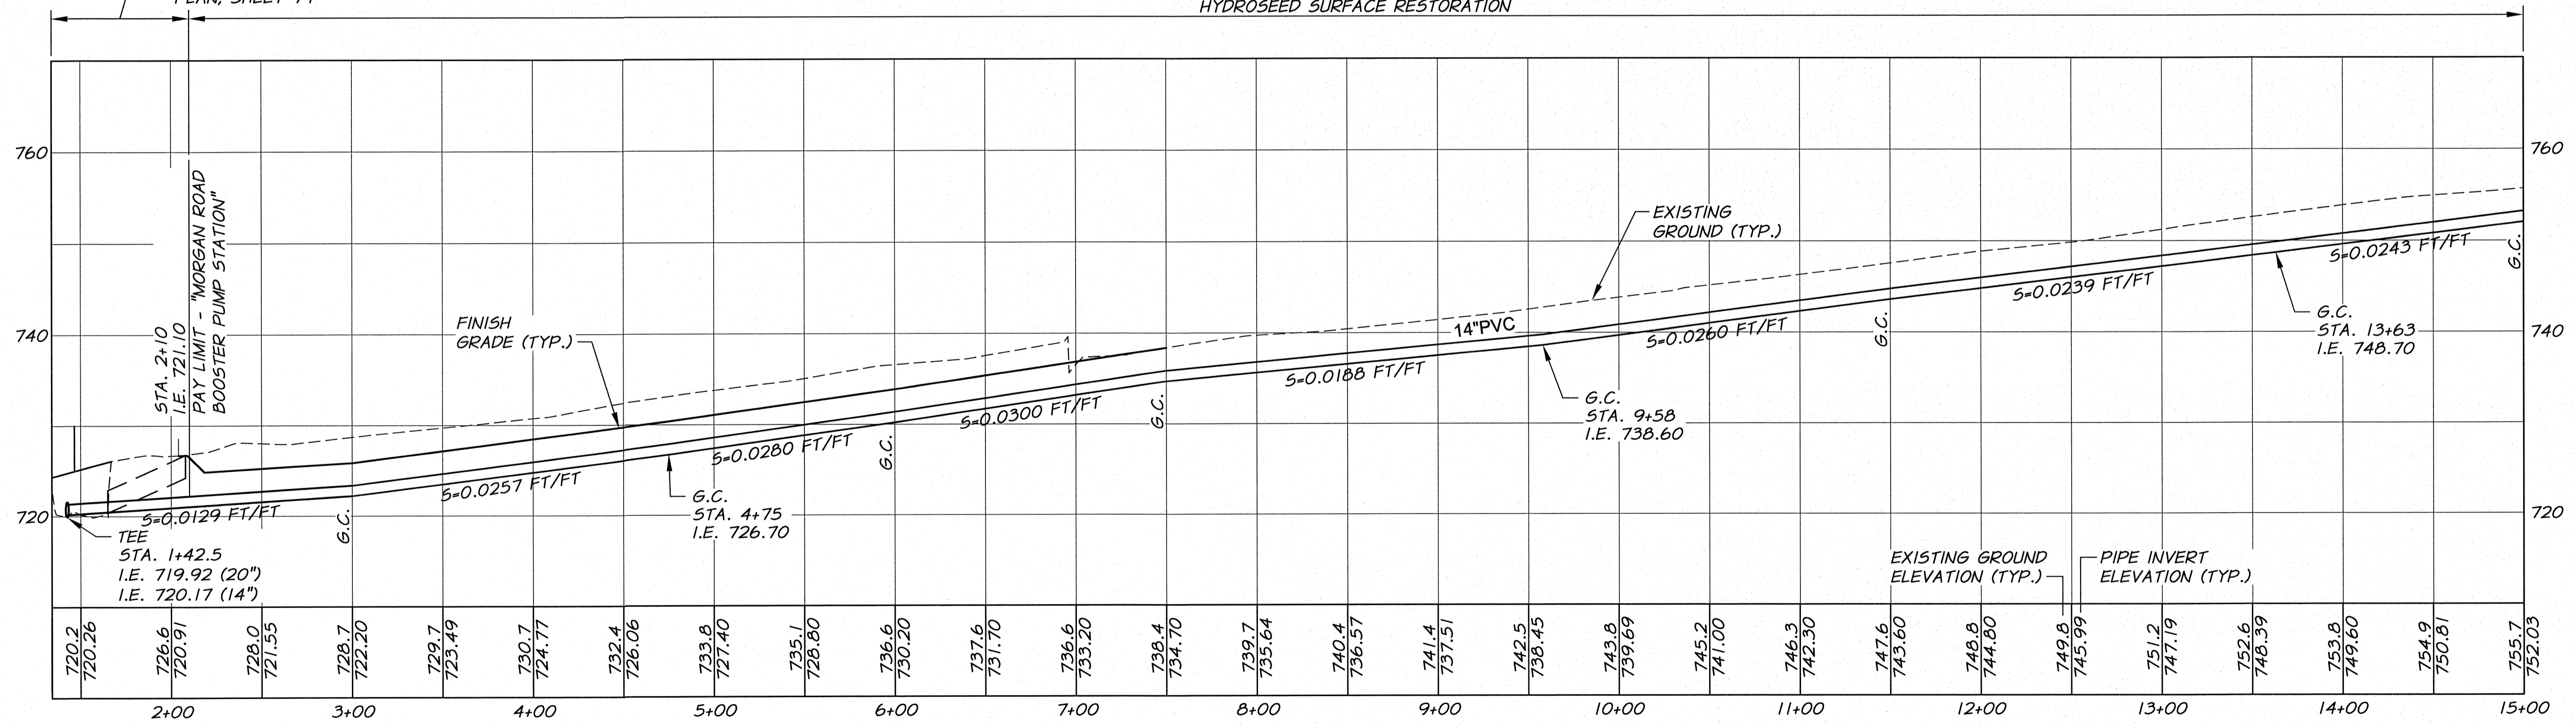
- WORK ITEMS**
- (A) EXISTING IRRIGATION LINE ALONG OR CROSSING ALIGNMENT. EXACT LOCATION UNKNOWN. REMOVE AND PLUG AS REQUIRED FOR NEW LINE INSTALLATION.
 - (B) EXISTING IRRIGATION CONTROL STRUCTURE TO BE REMOVED.

ASPHALT AND GRAVEL SURFACE RESTORATION SEE PUMP STATION SITE PLAN, SHEET 74

SECTION
N.T.S.
