RECORD DRAWING		BY	B.M.	DATE	5/13
DESIGNED BY	M. OWENS	HORIZ. SCALE	1" = 50'	VERT. SCALE	
DRAWN BY	D. CHRISTMAN	JOB NUMBER	1199-336	DATE	2012
REVIEWED BY	B. MOORE	ACAD FILE	PNP-Della.dwg	COPYRIGHT 2012 BY ANDERSON-PERRY & ASSOC., INC.

BENTON IRRIGATION DISTRICT
 IRRIGATION SYSTEM IMPROVEMENTS
 PHASE 3B
 DELLA AVENUE PIPING
 DELLA AVE.

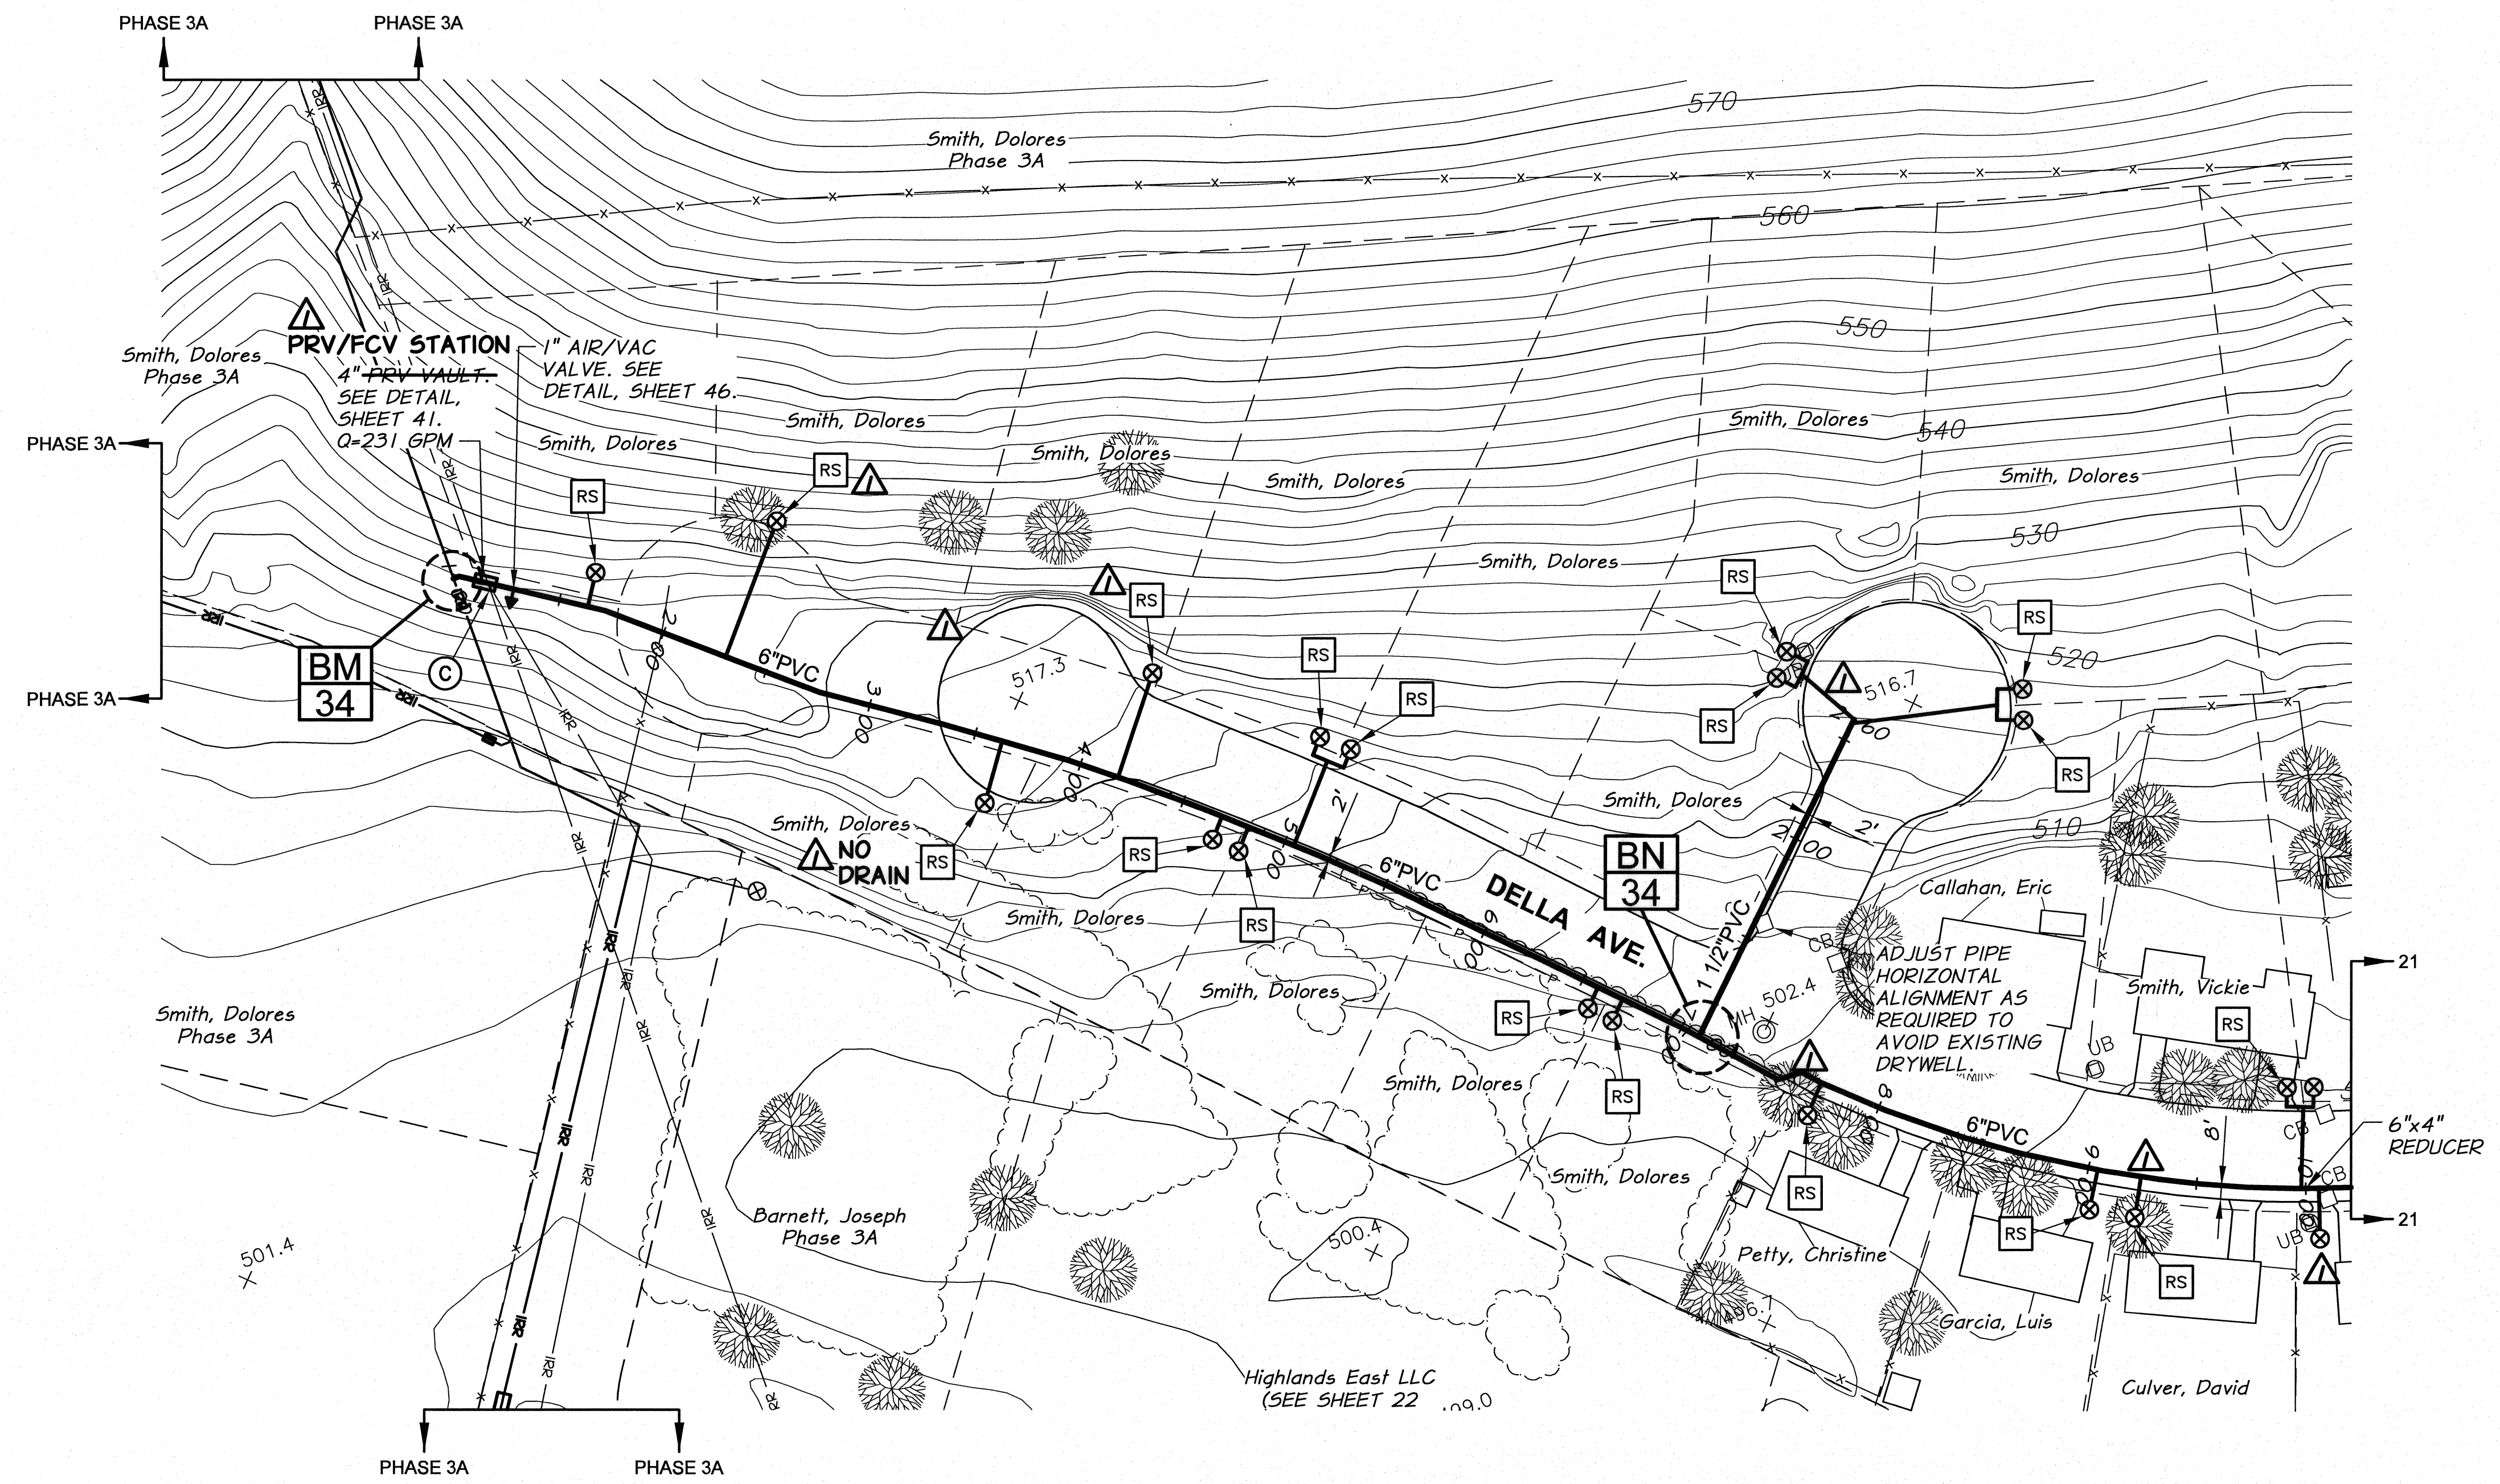
- MINIMUM COVER FROM FINISH GRADE TO TOP OF PIPE SHALL BE 2.5 FEET.
- MINIMUM SLOPE OF INSTALLED PIPING SHALL BE 0.003 FT/FT.
- LOT LINES AND RIGHT-OF-WAYS SHOWN ARE APPROXIMATE ONLY.
- IT IS ANTICIPATED THE TELEPHONE, POWER, CABLE T.V., WATER, AND SEWER THAT EXIST WITHIN THE STREET AND UTILITY CORRIDOR AND INDIVIDUALLY PROVIDE SERVICE TO EACH LOT WILL BE ENCOUNTERED DURING CONSTRUCTION. CONTRACTOR SHALL PLAN FOR CROSSING AND/OR EXCAVATING ALONG THESE UTILITIES AT EACH LOT AND/OR WITHIN THE STREET AND UTILITY CORRIDOR WITHOUT ADDITIONAL COMPENSATION.
- SERVICES LOCATED DOWNHILL OF MAIN LINE ARE TO DRAIN BACK TO MAIN LINE, UNLESS DESIGNATED "WITH DRAIN".

- (C) EXISTING IRRIGATION LINE ALONG ALIGNMENT TO BE ABANDONED. REMOVE AND PLUG AS REQUIRED FOR NEW LINE INSTALLATION.
